WADC TECHNICAL REPORT 53-192

## MECHANISM OF RAIN EROSION

Part XIII. Mechanism Studies on Neoprene Coatings

*Olive G. Engel*

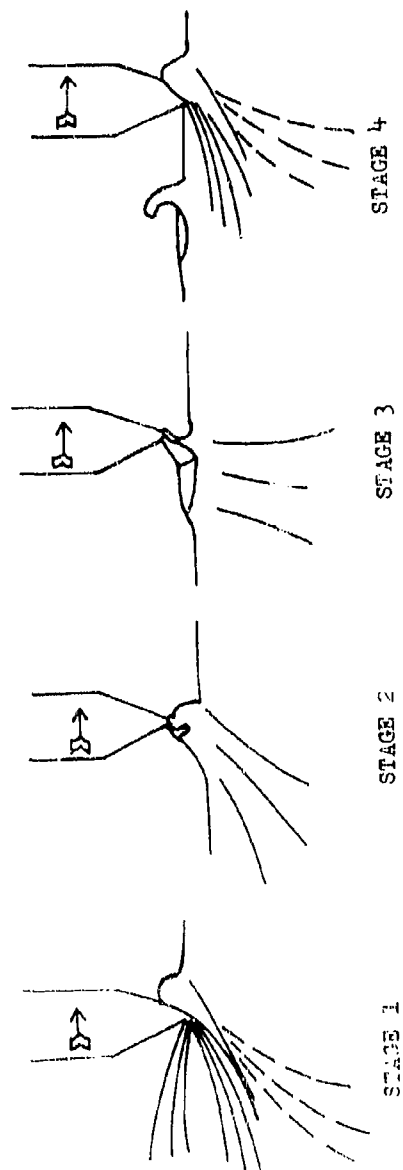
FIGURE 20 A SCHEMATIC REPRESENTATION OF THE "STICK-SLIP" PROCESS OF RUBBER ABRASION

The abrasion of rubber is also a "stick-slip" process. Schallamach [4,5,6] has found that the abrasion trace left by a needle on a pure gum vulcanizate rubber is not continuous. It consists of isolated pits or tears; the surface material between the pits or tears is undamaged. In regard to the abrasion caused by a needle, Schallamach postulated that (a) the needle pricks a small hole in the rubber, and, as the needle moves, a bulge of rubber is built up in front of it; eventually, (b) the needle moves over this bulge simultaneously pulling out a thong of rubber that breaks either at its root or at the needle tip. Step (a) is the "stick"-step and step (b) is the "slip"-step. See Figure 20. The mechanism of needle abrasion postulated by Schallamach depends on two factors, namely, the bulge of rubber must adhere by friction to the tip of the needle against the pull of the elastic forces, and the tensile properties of the material must admit of large deformation without failure.

Schallamach has found that an array of nearly parallel ridges is often produced on rubber surfaces by abrasion. He refers to this array as the "abrasion pattern". The ridges of the abrasion pattern run at right angles to the direction of abrasion and are asymmetric with respect to this direction. They are characterized by overhanging crests that lean against the direction of abrasion. According to Schallamach the ridges are all bent backwards during the abrasion and material is "removed by abrasion" from what in the relaxed state was the underside of the ridges. Schallamach remarks that the origin of the abrasion pattern is not yet fully understood and states that it "is most probably a consequence of the combination of high elasticity and high coefficient of friction which is characteristic of rubber".

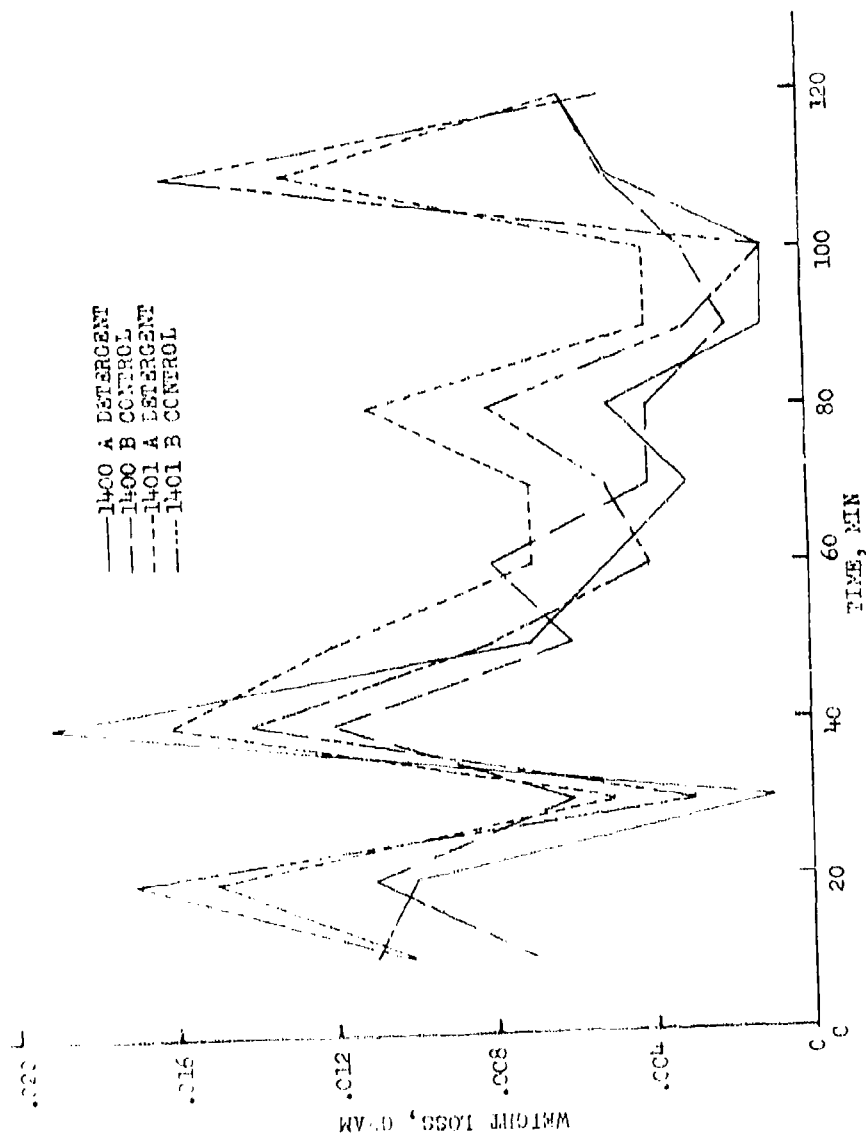
FIGURE 23 WEIGHT-LOSS-VERSUS-TIME CURVE FOR FOUR NEOPRENE COATED SPECIMENS

dried in a dessicator overnight and were then weighed on a chemical balance. Two of the specimens (Cornell Aeronautical Laboratory numbers 1400 A and 1401 A) were brushed with a concentrated solution of alkyl aryl sulfonate and were air dried for at least one hour. Each of these specimens was tested with an untreated control specimen (Cornell Aeronautical Laboratory numbers 1400 B and 1401 B) at a velocity of 600 mi/hr in 1-in./hr artificial rain. After each 10-min interval of the first two hours of the test, the four specimens were dried in a dessicator overnight and were then weighed before another film of detergent solution was applied to the treated specimens. This procedure was repeated at 20-min intervals during the remainder of the test. The weight losses of these specimens at the end of the 10-min intervals of test during the first two hours of test are plotted in Figure 23.

Inspection of the eroded specimens at X 20 magnification revealed that specimens 1400 A (treated with detergent) and 1400 B (control), which were tested for a total of 260 min, were in about the same state of erosion. There was a fairly distinct chevron pattern at the low-speed end of these specimens and small coating bubbles and torn-out spots at the high-speed end. Specimen 1401 A (treated with detergent) appeared to be slightly more eroded than specimen 1401 B (control). These specimens were tested for a total of 320 min. There was a strong chevron pattern at the low-speed end, a general beadiness in the central part of the leading edge, coating bubbles over most of the leading edge, and torn-out spots at the high-speed end of these specimens. All four specimens contained quite a few cracks or sutures that may be due to attack of the neoprene by ozone or by hydroxyl ion.

The microscopic inspection showed that there was little if any difference in the appearance of the specimens treated with the alkyl aryl sulfonate and the controls. From this it can be concluded either that the alkyl aryl sulfonate washed off too soon to be of any real benefit or that it was of little consequence to the erosion damage whether the surface of the coating was hydrophilic or hydrophobic.

From Figure 23 it can be seen that the weight loss sustained by the specimens in equal intervals of time is not constant. During the first two hours of test, peak losses occurred in the intervals 10 to 20 min, 30 to 40 min, 70 to 80 min, and 100 to 110 min. This seems to indicate that there are preparation periods, in which little or no erosion loss occurs, followed by periods in which loss is accomplished. The preparation periods may be characterized by the development of structures without loss of material, such as coating bubbles, which are later torn open with loss of material. The development of surface cuts, cracks, or tears without loss of material may, similarly, be followed by a tearing away of small pieces of the coating when the water from additional impinging drops is driven into them, or by the falling away of pieces of coating material from between circumscribing cracks.

The rain-erosion of neoprene coatings is a two-step process consisting of periods of preparation in which little loss of material occurs followed by periods of erosion or loss of material. This is clearly shown in the graphs of Figure 23 and 25. The gradual development of a network of ozone-type cracks with eventual breaking away of material between circumscribing cracks is such a two-step process.

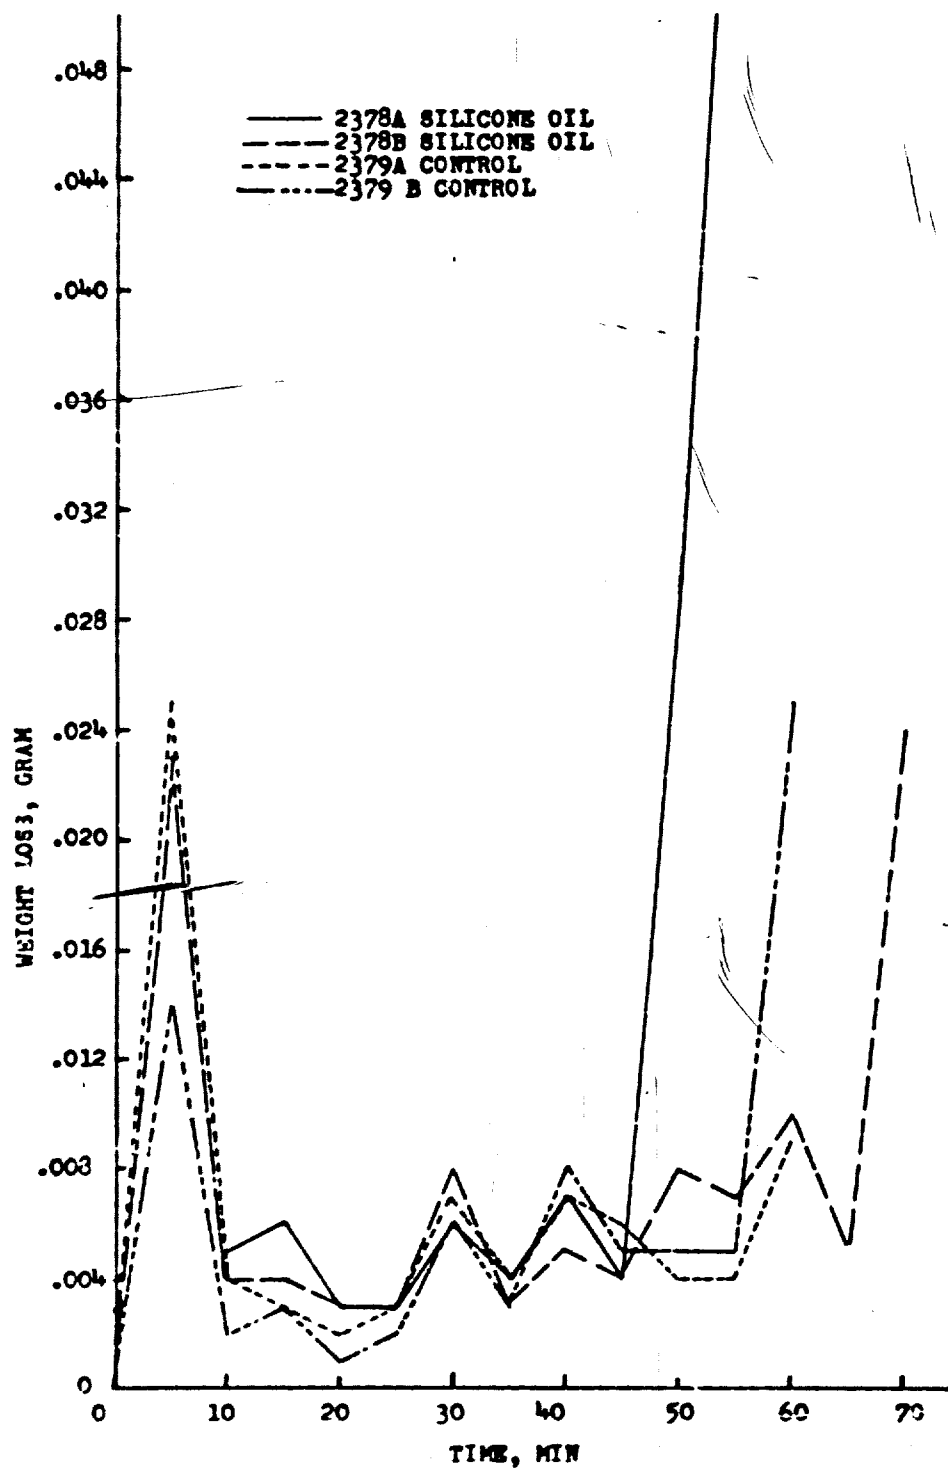
FIGURE 25 WEIGHT-LOSS VERSUS TIME CURVE FOR FOUR NEOPRENE COATED SPECIMENS TWO OF WHICH WERE COATED WITH SILICONE OIL DURING TEST

An additional test of the effect of application of oil to the specimens was made using silicone oil, which it was thought might be more tenacious than the castor oil that was used. Four 2024-O aluminum alloy airfoil-shaped test specimens were fabricated at the Cornell Aeronautical Laboratory and were brush coated with Goodyear 23-56 neoprene using Bostik 1007 as the primer. The coating thickness was approximately 11 mils. After air drying for five days the specimens were placed in a desiccator overnight; they were then weighed. Specimens 2378 A and 2378 B were brushed with a thin film of silicone oil (viscosity 300 centistokes) prior to rain-erosion test at a velocity of 500 mi/hr in 1-in./hr rain. Specimens 2379 A and 2379 B were not coated with the silicone oil. At the end of a 5-min test interval the specimens were stored in a desiccator overnight and were weighed again. Specimens 2378 A and B were then brushed again with silicone oil and the cycle of procedure was repeated. The total test time accumulated on the specimens was from 60 to 70 min. The weight losses that were sustained by the specimens are shown graphically in Figure 25.

Microscopic examination of the specimens led to the conclusion that the type and degree of damage that was sustained by the oil-treated specimens and by the control specimens was about the same. In general, it consisted of a dim chevron pattern at the low-speed end of the specimen and of broken out spots at the low-speed end which increased in density toward the high-speed end until at the high-speed end there was a swath down the center of the specimen from which a complete layer of coating material had been removed. There was evidence of crack formation in the coating at both ends of the specimens.

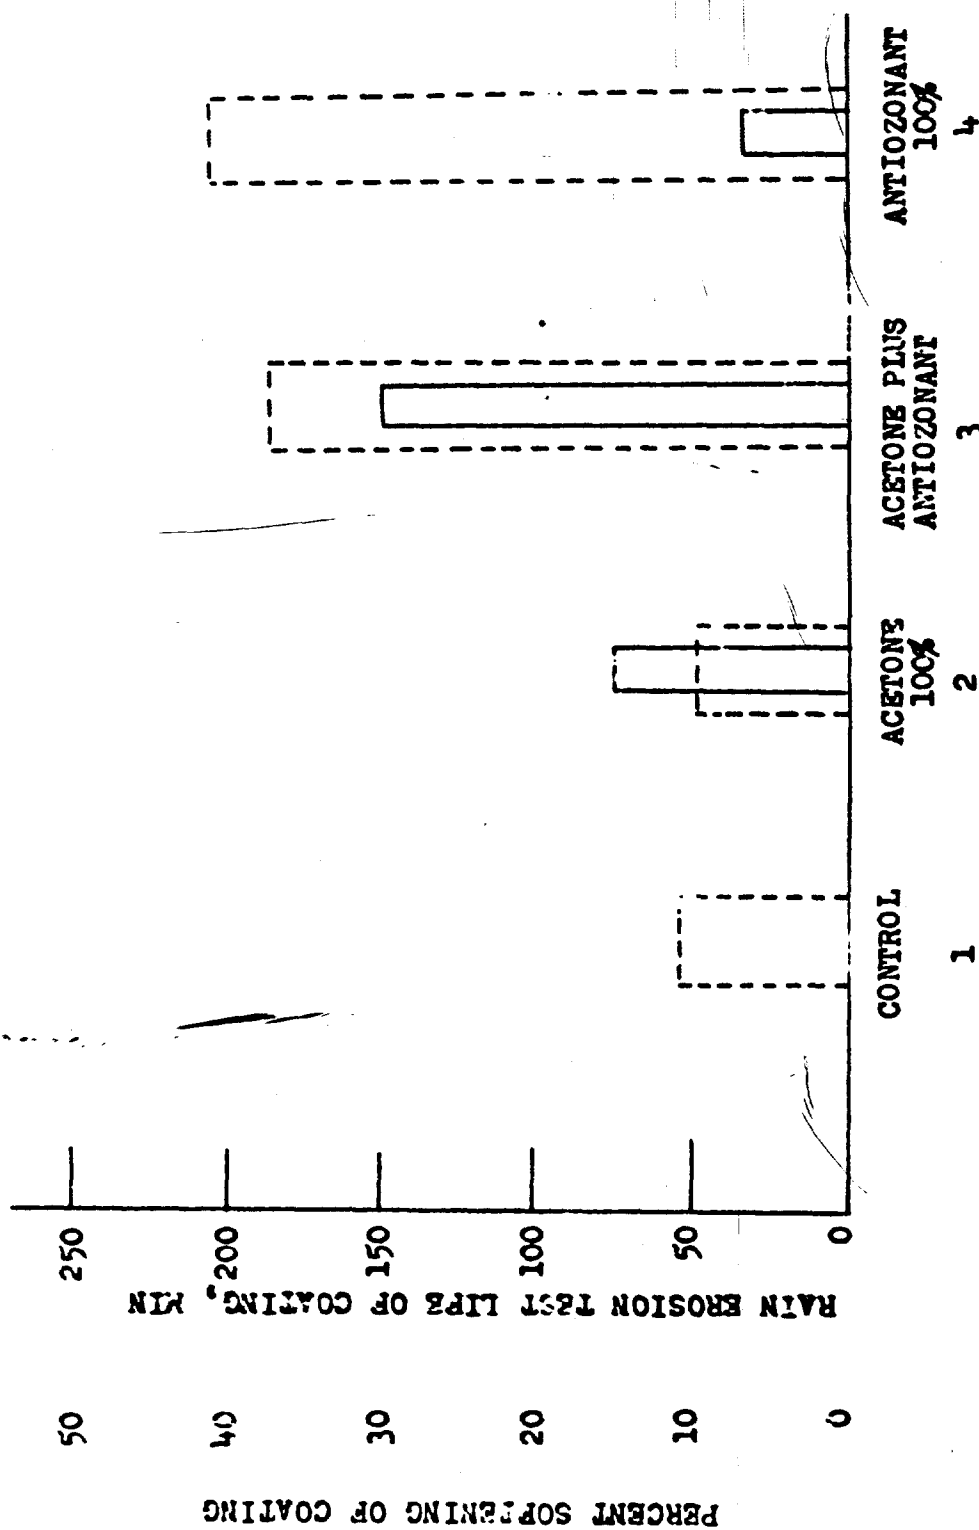
The Cornell Aeronautical Laboratory reported that the neoprene coatings were softened by the antiozonant alone, by acetone alone, and by the solution of antiozonant in acetone. For the three reagents that were used to treat the coatings, the greatest swelling and softening resulted from the use of antiozonant-acetone solution and the least swelling and softening resulted from the use of 100 per cent antiozonant. Their data are presented graphically in Figure 26.

Treatment of the neoprene with 100 percent acetone had no effect on its rain-erosion test life. The acetone evaporated very rapidly. Softness of the neoprene coating that resulted from the use of 100 per cent acetone vanished with the acetone. Therefore, whatever effect the softening of the neoprene had on its rain-erosion test life must be determined from the results obtained on treatment with the acetone-antiozonant solution and treatment with 100 per cent antiozonant. A comparison of bar graph 3 with bar graph 4 in Figure 26 indicates that a 30 per cent softening of the coating is associated with a 180-min test life when acetone plus antiozonant was used whereas a 7 per cent softening is associated with a 220-min test life when antiozonant only was used. From these data it cannot be concluded that test life was determined by the softness of the coating. Furthermore, Beal, Lapp, and Wahl [17] have concluded that "in the neoprene rubbers tested, those with the greatest resiliency, lowest permanent set, and high Durometer hardness, had the best resistance to rain erosion". Softness would therefore not appear to be the correct explanation. It has been suggested that the

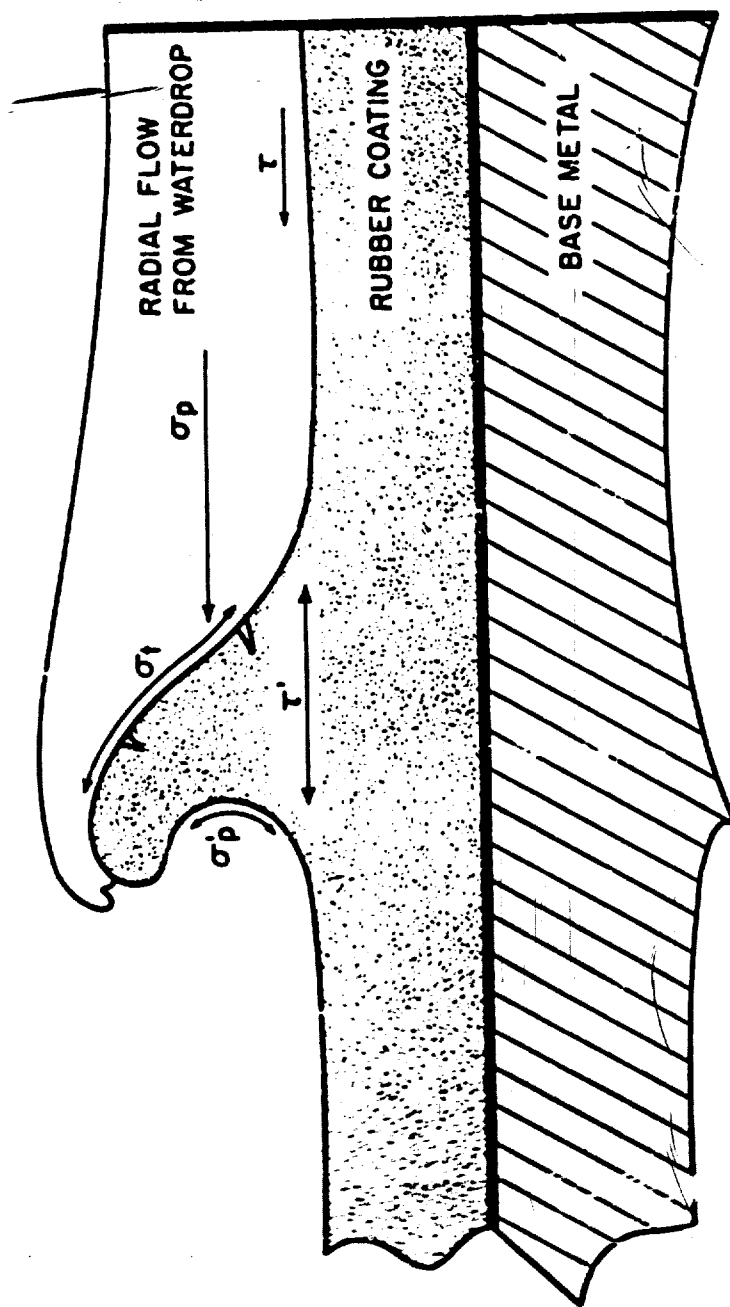
FIGURE 27 STRESSES THAT RESULT WHEN A WATERDROP RUNS OVER A SURFACE PROTRUSION

When the liquid from a drop that is flowing radially runs over a surface protrusion it exerts forces against the protrusion that are opposed by the restraint of the bonding of the protrusion to the underlying layers of material. Pressure,  $\sigma_p$  of Figure 27, is exerted against the protrusion by the flowing liquid. The pressure that is exerted by the liquid tends to move the protrusion along the planar surface of the solid and results in a shear stress,  $\tau$  of Figure 27, at the base of the protrusion. The flow of the liquid results in the shear stress  $\tau$  that was discussed above.

The pressure exerted by the liquid also results in a turning moment that tends to bend the protrusion over. The turning moment is the integrated cross product of the compressive force exerted by the liquid and the elevation of the protrusion above the planar surface of the solid at the point where the force is applied. As the protrusion bends, a tensile stress,  $\sigma_t$  of Figure 27, appears on the side of the protrusion against which the compressive force is applied and a compressive stress,  $\sigma_c$  of Figure 27, appears on the opposite side of the protrusion. If the force exerted by the rapidly running liquid is sufficiently great or if the protrusion has a sufficient elevation above the planar surface, failure may occur. Whether the protrusion is simply bent over, whether it is broken off, or whether part of the solid material below the surface is torn out with it depends on the strength of the material and on where failure occurs first. Likely points of failure are marked with notches in Figure 27.

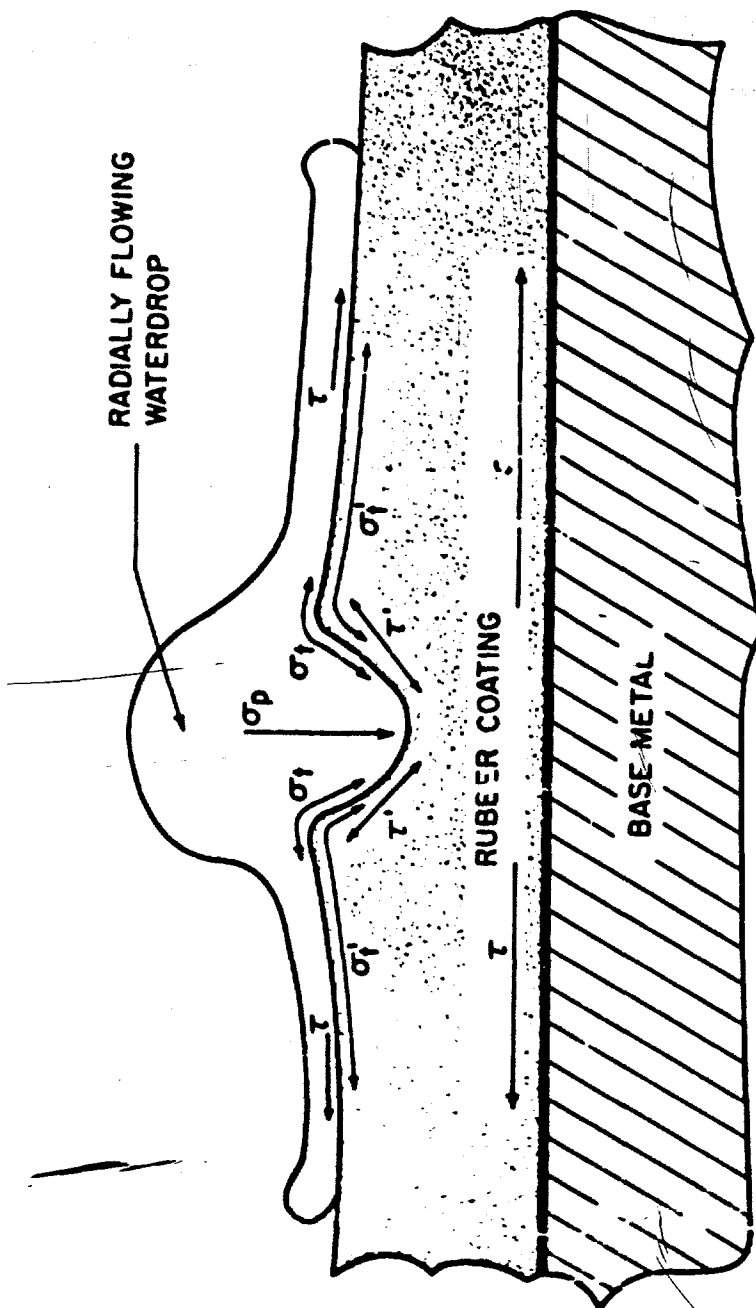
FIGURE 28 STRESSES THAT RESULT FROM THE COLLISION OF A WATERDROP WITH  
A RUBBER-COATED SURFACE

If a waterdrop impinges against a rubber-like material the effect of the compressive stress,  $\sigma_p$  of Figure 28, which is the direct result of the collision, is to compress the solid material at the point of impingement. The local compression results in a dimple or cup-shaped cavity. Tensile stresses,  $\sigma_t$  of Figure 28, appear in the sides of the dimple and especially in the knee in the solid material at the rim of the dimple. If these tensile stresses are sufficiently great tears may form in the surface layers of the solid material. The material that formerly occupied the volume that now forms the hollow of the dimple is displaced. It is moved radially outward and upward around the dimple and this results in a shear stress,  $\tau$  of Figure 28.

The radial flow of the liquid of the drop imposes a radial tensile stress,  $\sigma_t$ , of Figure 28, and a shear stress  $\tau$ , which was discussed above. In the case of very thin rubbery coatings it is possible that the shear stress  $\tau$  may be transmitted through the coating to the primer bonds, which hold the coating to the base metal, and that it may cause failure of the primer-to-rubber or of the primer-to-metal bond. See pictures 2(c) and 3(c) of Figure 10 and the discussion relating to these pictures.

It was brought out in Section 5.1.1 that if a waterdrop impinges against a rubber-like material the effect of the compressive stress  $\sigma_c$  of Figure 28, which is the direct result of the collision, is to compress the solid material over the area of impingement of the drop itself. The wave of compression that moves through the coating as a result of the collision eventually reaches the primer. The compressional wave is partially transmitted into the primer and partially reflected from it. The reflected portion of the compressional wave is a tension wave that moves back to the surface of the rubber coating. The transmitted portion of the compressional wave moves through the primer and eventually reaches the substrate. Reflection and transmission occur again at the interface between the primer and substrate.
